# ROAD CONDITION SURVEY FOR THE FOREST ROAD SYSTEM IN THE KENAI PENINSULA BOROUGH

PREPARED FOR: The Alaska Sustainable Salmon Fund (AKSSF)

DATE OF REPORT: March 1, 2015

PREPARED BY: Joel Nudelman, Forest Practices/Resource Forester, Alaska Department of Natural Resources Division of Forestry, Juneau, AK (907) 465-5406

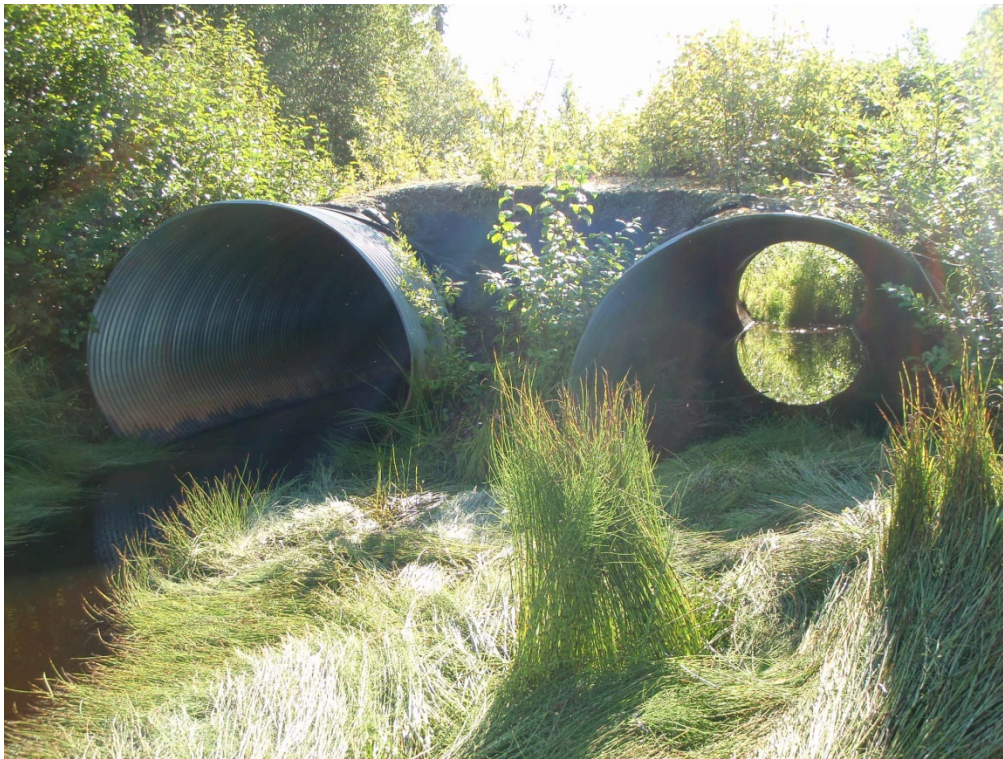
Most road surfaces were in excellent shape, with regular maintenance taking place. Much of the road system had an adequate number of drainage structures and water moved quickly off the roads after rain events. Some of the lower ratings were related to culvert sizing, where pipes were narrower than bed width. Also, the BMP related to a culvert's ability to withstand a 25 year storm event caused some lower ratings. Additionally some lower ratings were noted on the BMP related to perched culverts on fish bearing waters. The BMP's for culvert perch was discussed in the fish culvert section. The remaining BMP scores showed full implementation or close to full implementation (ratings of 3 or 4). The overall BMP rating average for MHT ownership was 3.46 (out of 4). The average on Municipal roads, which belong to the SOA at the time of construction, was 2.5. The Native corporation road system had an average rating of 3.22 while the SOA's was 3.14.

Figure 13. Twin culverts with a rating of 4, Tyonek.

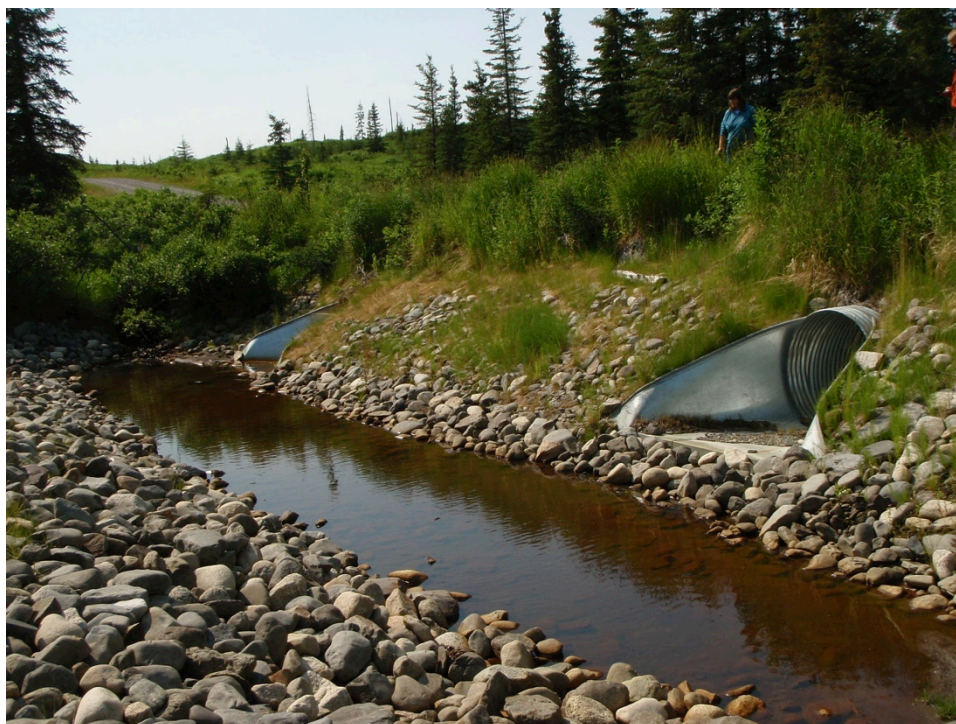
Figure 14. Culvert replacement with relief pipe on NNA1047.

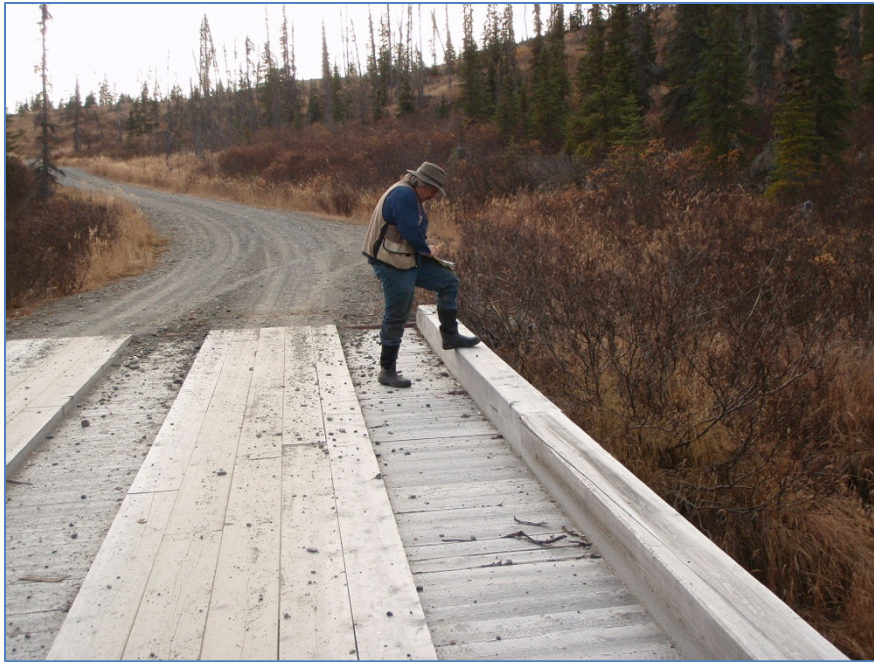
Figure 15. Rating bridge over Lower Ninilchik.

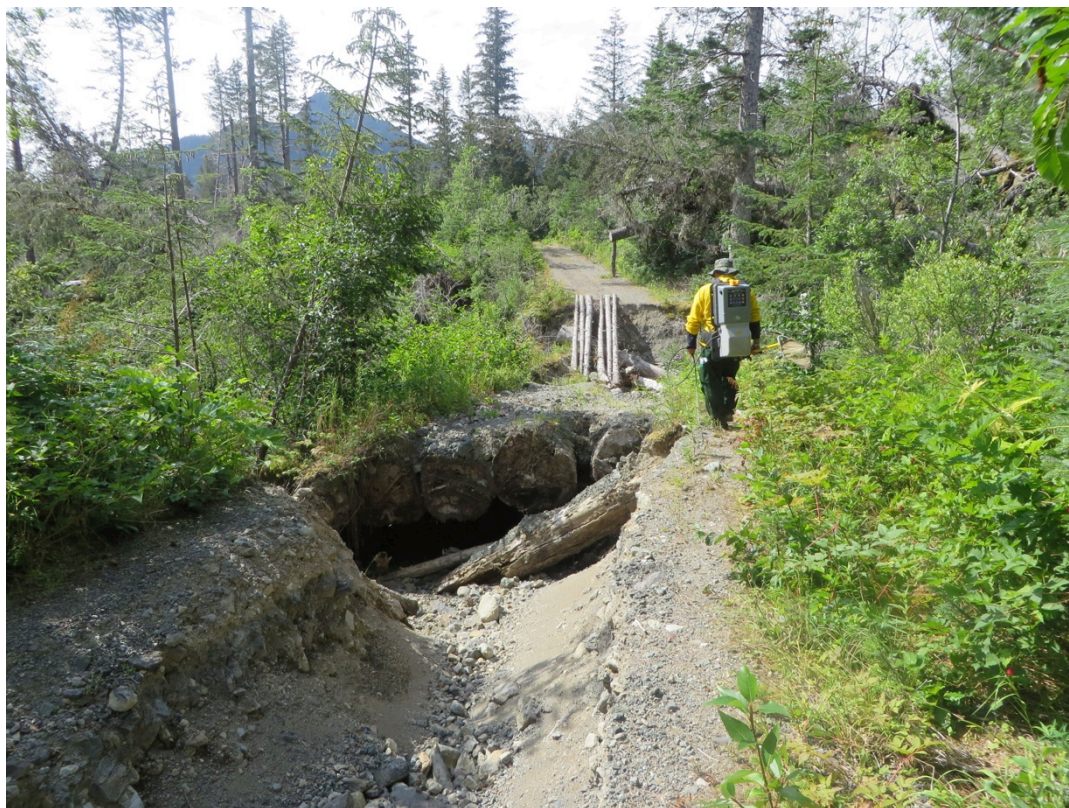
Figure 17. Collapsed log stringer bridge on Stream No. 242-32-10160 (Bridge 157 on Figure 11 map)

The six log stringer bridges highlighted in Tables 10 and 11 will need to be pulled apart, with the material moved away from where it could reenter the stream. One structure, 1B157 on a stream 242-32-10160 has fallen into the stream and a log jam has developed upstream of the bridge (see map on Figure 11, photo on Figure 17). About 75 adult pink salmon were observed spawning near the bridge, according to the Habitat biologist.

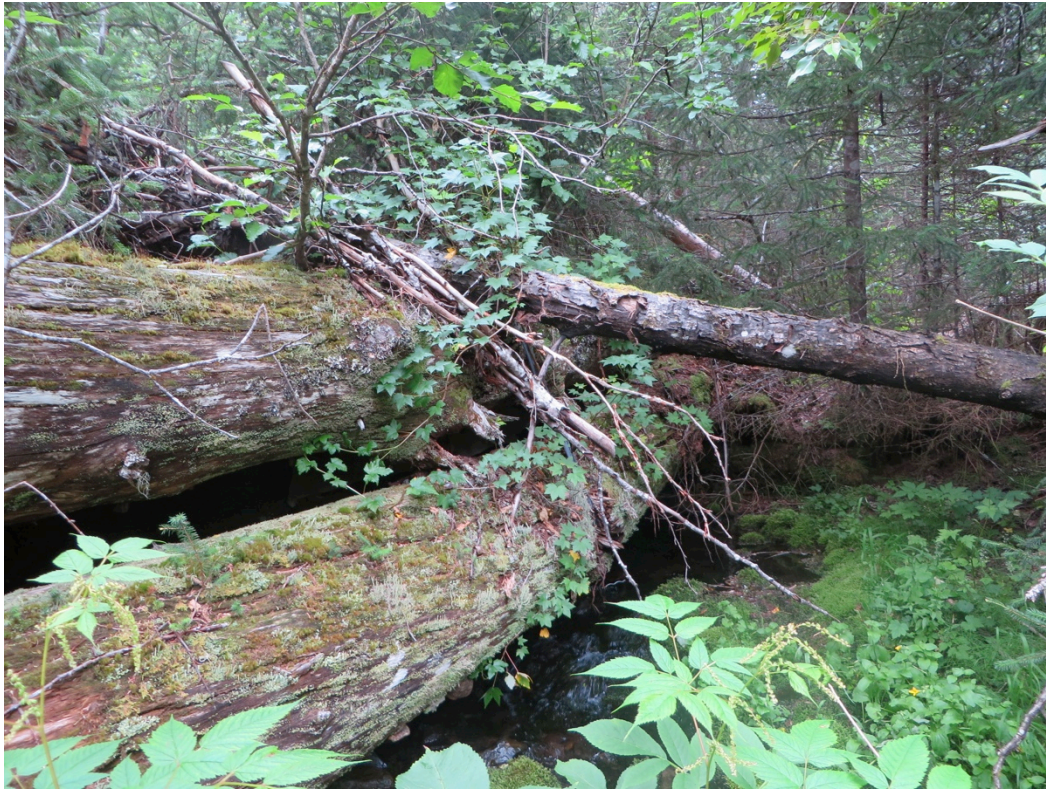
Figure 18. Failing log stringer bridge on Stream No. 241-11-10740 (Bridge 219 on Figure 10).
