Tongass National Forest

Water Quality Best Management Practices – Annual Monitoring Report

Fiscal Year 2019

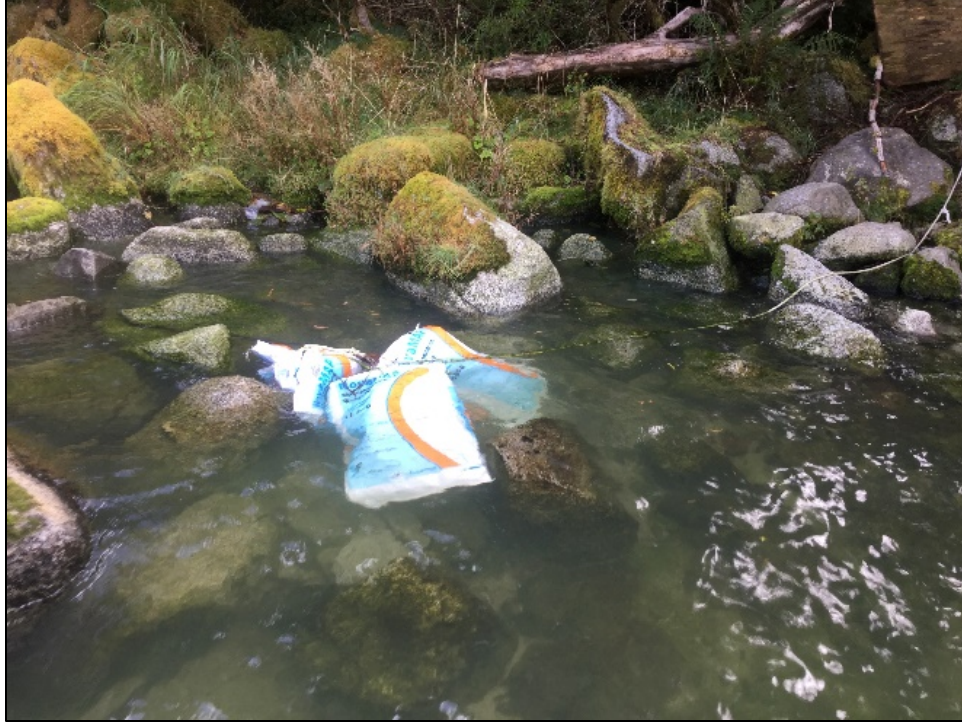
The BMP evaluation was conducted on September 5th, 2019 while fertilizer was being applied, and the entirety of the waterbody along with the onsite fertilizer staging location was evaluated. Other than the intended increase to primary productivity, visual field observations found no evidence of adverse consequences to water quality or aquatic health as a result from chemical use. BMPs regarding chemical transport, storage and disposal along with water quality monitoring as identified in standard operating procedures and chemical handling instructions were followed. No visual evidence of chemical spills or leaks were observed.

Photo 2. One of five application sites where punctured bags of fertilizer soak and dissolve while tethered to shore.

- To support program continuity of BMP implementation, it's recommend to summarize the suite of guiding procedural documents into a formal project plan. This document should include project specific BMP provisions that adhere to/reference Region 10 BMP Guide FSH 2509.22 Chapter 10 BMP 18.5 Lake Fertilization for Fish Habitat Improvement, and National Core BMP Tech Guide (2012) Chem-4 Chemical Use in Waterbodies.

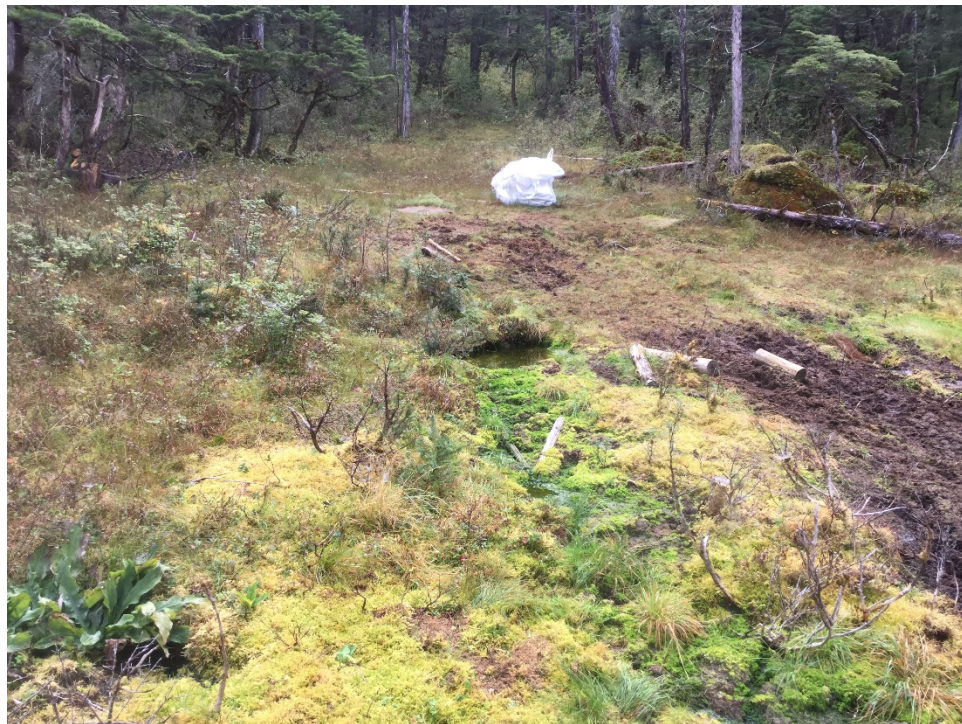
Photo 3. Onsite fertilizer staging area along the southern lakeshore. Bags of fertilizer are kept inside the large white helicopter sling bag.

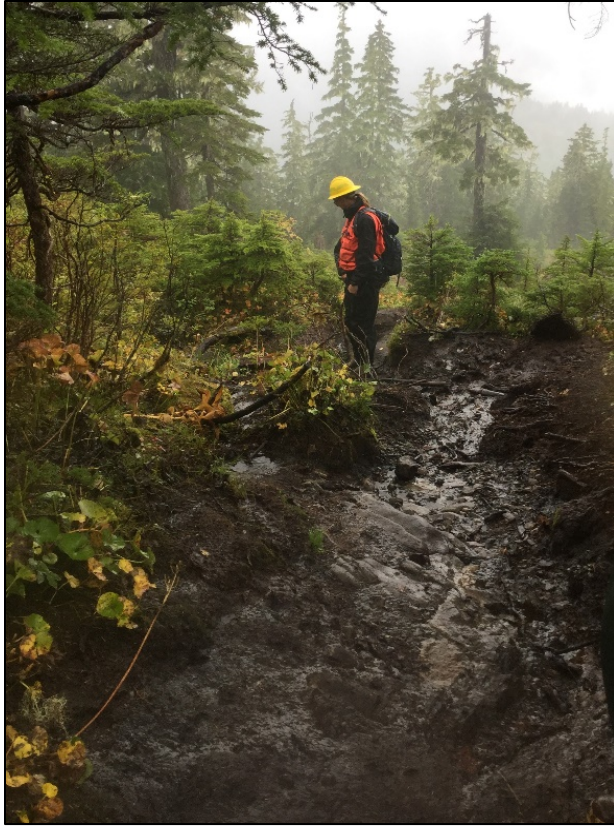
Evidence of erosion and sedimentation was observed both inside and outside the evaluated waterbody crossing. Forms of erosion identified included rill and sheet erosion, rutting, vegetation damage and bare ground, and localized sediment deposition. Routine trail INFRA inspections have been completed on the recommended five year rotation. These inspections have documented maintenance needs that have gone unresolved, some of which have been contributing to the erosion and sedimentation issues observed in this evaluation. No evidence of trash or domestic animal or human sanitary waste was observed.

Photo 4. Rill-eroded section of evaluated trail segment.

- Complete the 2019 Trail Assessment Condition Survey (TRACS) maintenance items that include BMP provisions to reduce trail erosion and sedimentation. The maintenance items include improved tread, water control features, geotextile mat replacement, rehabilitation of user created trails, and reconstructed or rerouted sections of trail.
- Install more frequent and longer water bars that fully span across the trail, using 3" base material for improved drainage in deeply incised sections of trail, deterring use of user created trails/shortcuts with brush and trail signs, and rerouting sections of trail along drier routes and extending switchback distances.

- Ensure maintenance needs are completed shortly after being identified and O&M plans are followed. In the case of Dude Mtn Trail, maintenance needs were identified as early as 2008 but have yet to be acted on. At this point the trail needs to be reconstructed.
- Trails traversing wetlands in alpine areas with high traffic levels should be designed and constructed to a more robust standard than trails on uplands. More robust trail construction will help avoid the long-term deferred maintenance identified on the Dude Mountain trail.

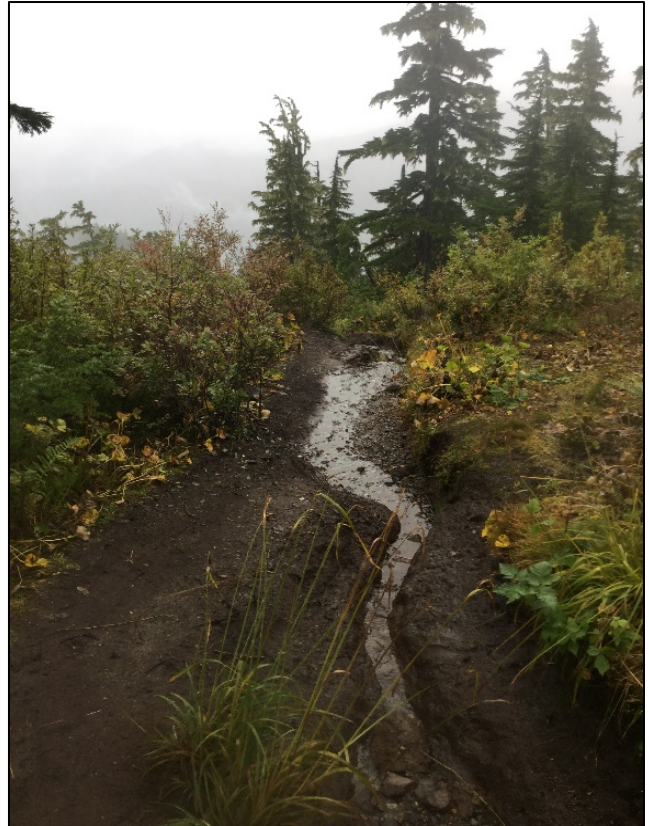
Photo 5. Poor drainage within evaluated trail segment.

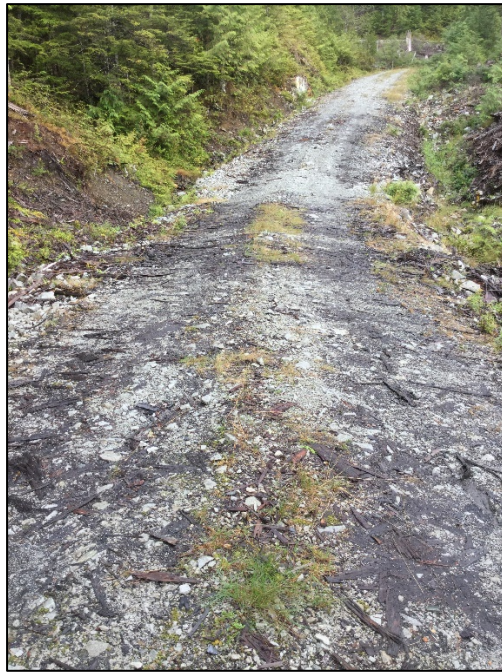
Supplemental erosion control was applied to skid roads and trails as planned and showed to be effective. There was no evidence of erosion or sedimentation observed from the log deck or within the RMA. There was no visual evidence of chemical or fuel spills or leaks or waste containers.

Photo 6. Pump Harvest Unit 77 Landing on FS-system road 51544.

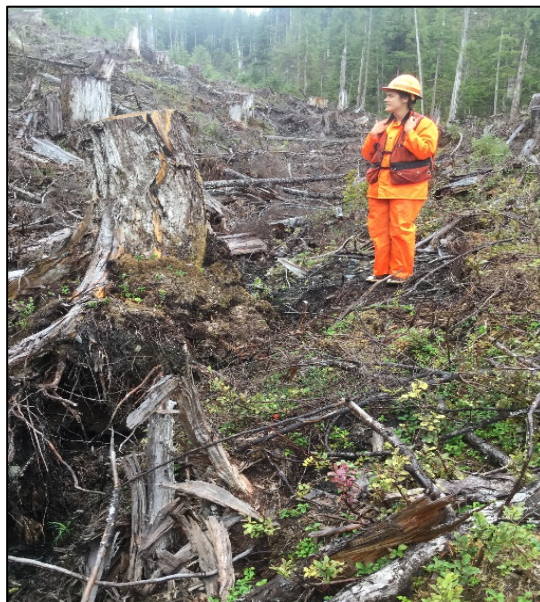
Adequate BMP's were included in the project contract/plan, however the provision regarding vegetation treatment near the waterbody was not fully implemented. Riparian buffer widths were measured in the field during the evaluation for verification. They fell short of the required 130ft minimum horizontal distance buffer in a few sections, with the narrowest distance measuring 90ft. The riparian buffer extent was shown on the sale area map and marked on the ground, but implemented too small in these few sections.

Photo 7. Chelsey Bach, Forestry Technician evaluating the shovel trail on the Pump Harvest Unit 77, Wrangell Ranger District.

- Ensure Class I stream buffers meet minimum 100ft horizontal distance and FP channels receive appropriate RMA buffer (greatest of flood plain, riparian vegetation or soils, riparian associated wetland fens, or 130ft). Unit boundary coincided with deep notch/vertical cliff in vicinity of stream transition from FPM to MCM.

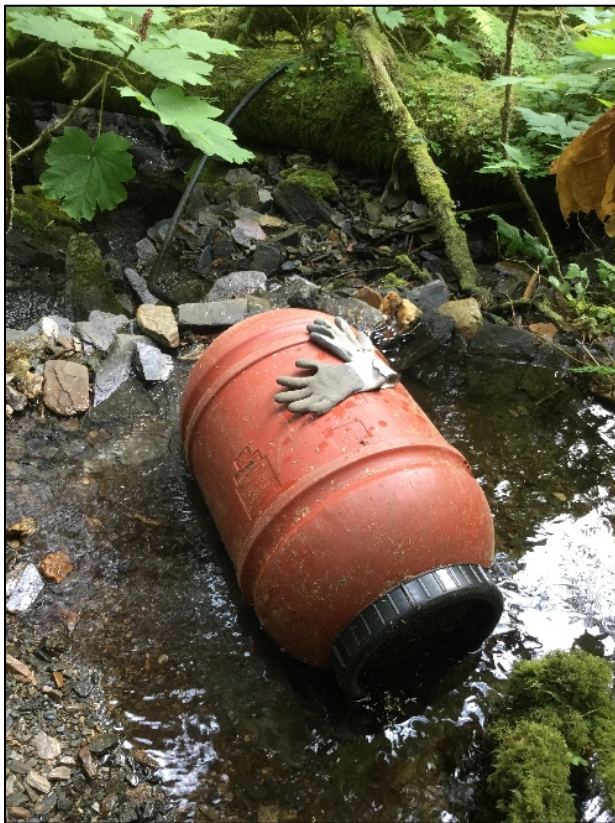
The evaluation, conducted August 13th, 2019, considered the operation and maintenance of the waterline facility. Overall BMP's were found to be successfully planned, implemented and effective. The collection system and waterline appear to be operating as intended. Water automatically spills over the rock dam to maintain natural streamflow at all ranges of flow, with no impacts to stream morphology or water quality. There was no evidence of erosion, water leakage, hazardous materials or other pollutants.

Photo 8. Maas waterline collection feature.

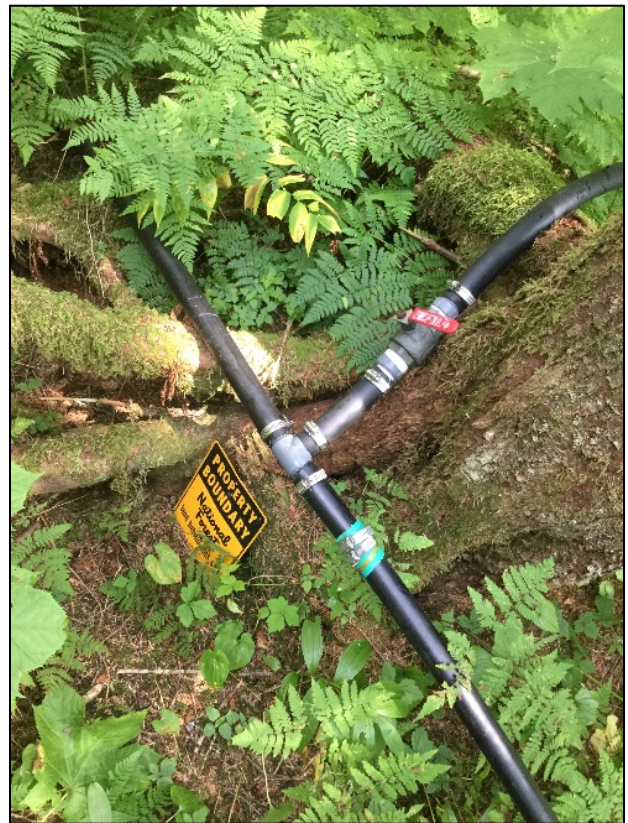
Photo 9. Maas waterline pipe junction.
