# ROAD CONDITION SURVEY FOR THE FOREST ROAD SYSTEM IN THE KENAI PENINSULA BOROUGH

PREPARED FOR: The Alaska Sustainable Salmon Fund (AKSSF)

DATE OF REPORT: March 1, 2015

PREPARED BY: Joel Nudelman, Forest Practices/Resource Forester, Alaska Department of Natural Resources Division of Forestry, Juneau, AK (907) 465-5406

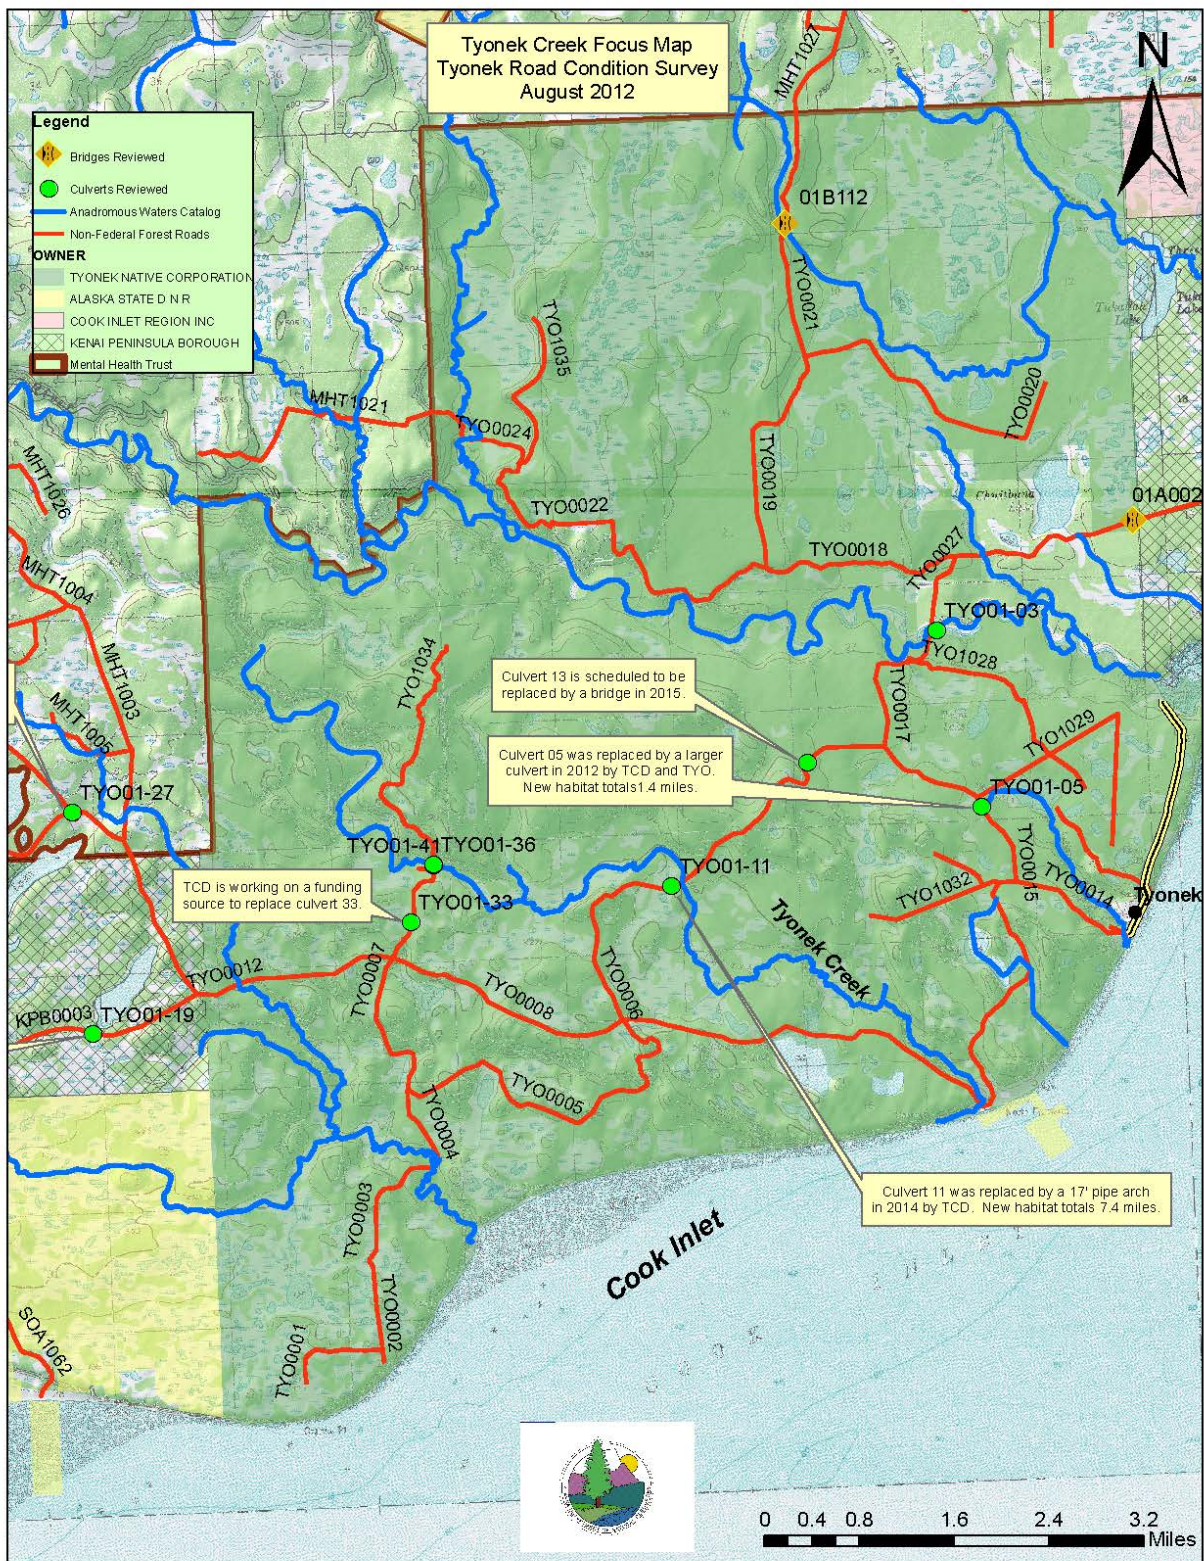
Figure 7. Map showing fish culverts in need of attention and projects accomplished in the vicinity of Tyonek creek. All culvert replacements projects have been developed and administered by the Tyonek Tribal Conservation District and Tyonek Native Association.

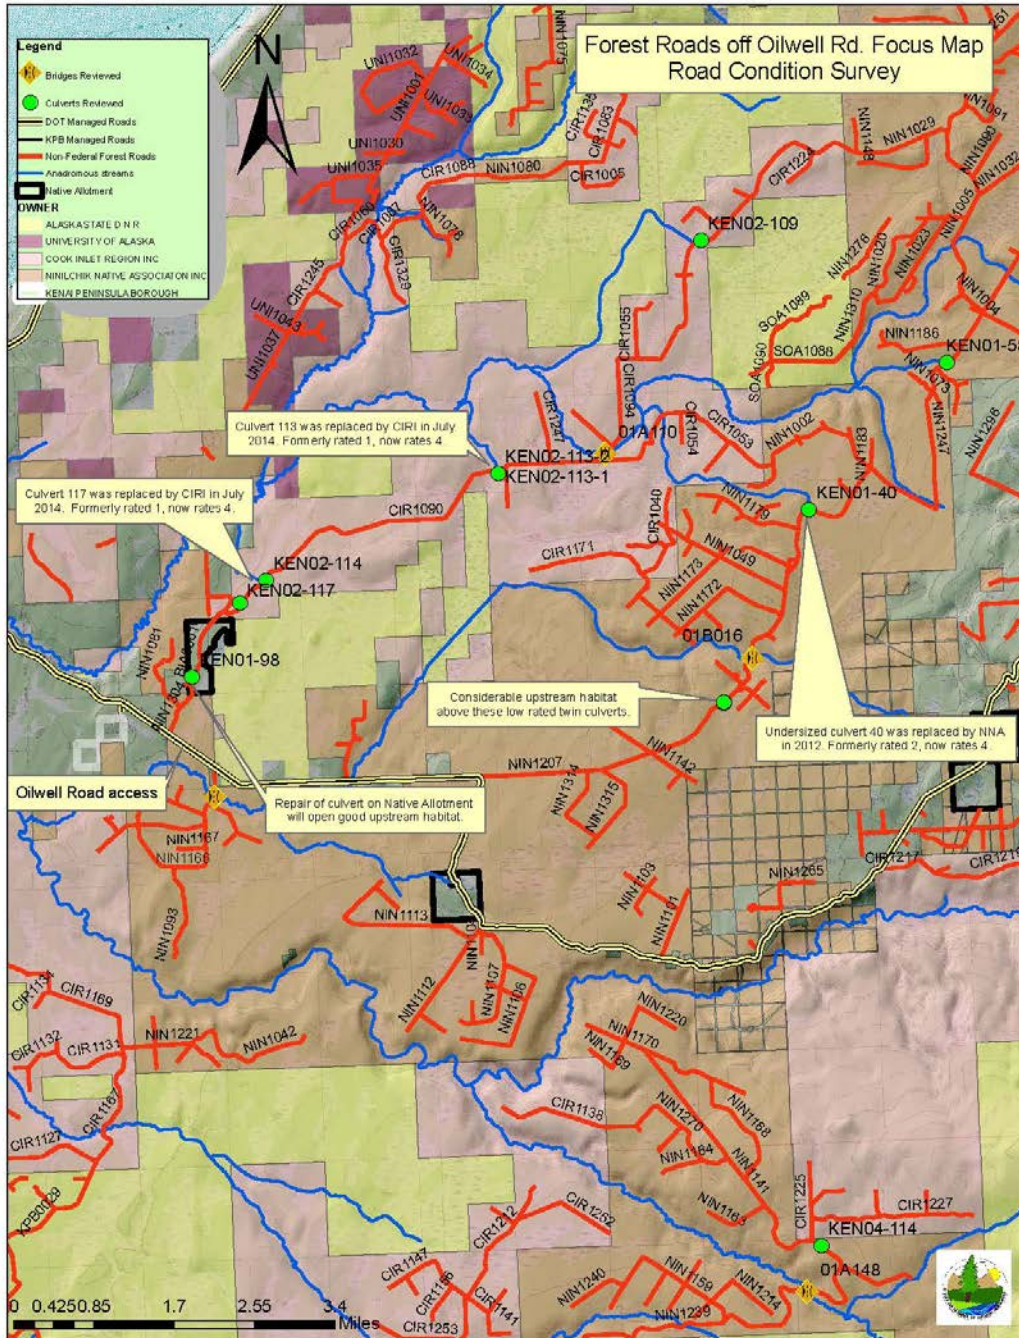
Two additional low-rated culverts remain on both the CIRI and NNA road systems. There's an additional low-rated culvert on a Native allotment, which is an inholding of NNI. DOF will work with the landowners to seek funding sources for their replacement.

Figure 8. Map showing low-rated fish culverts and replaced culverts by CIRI and NNA.

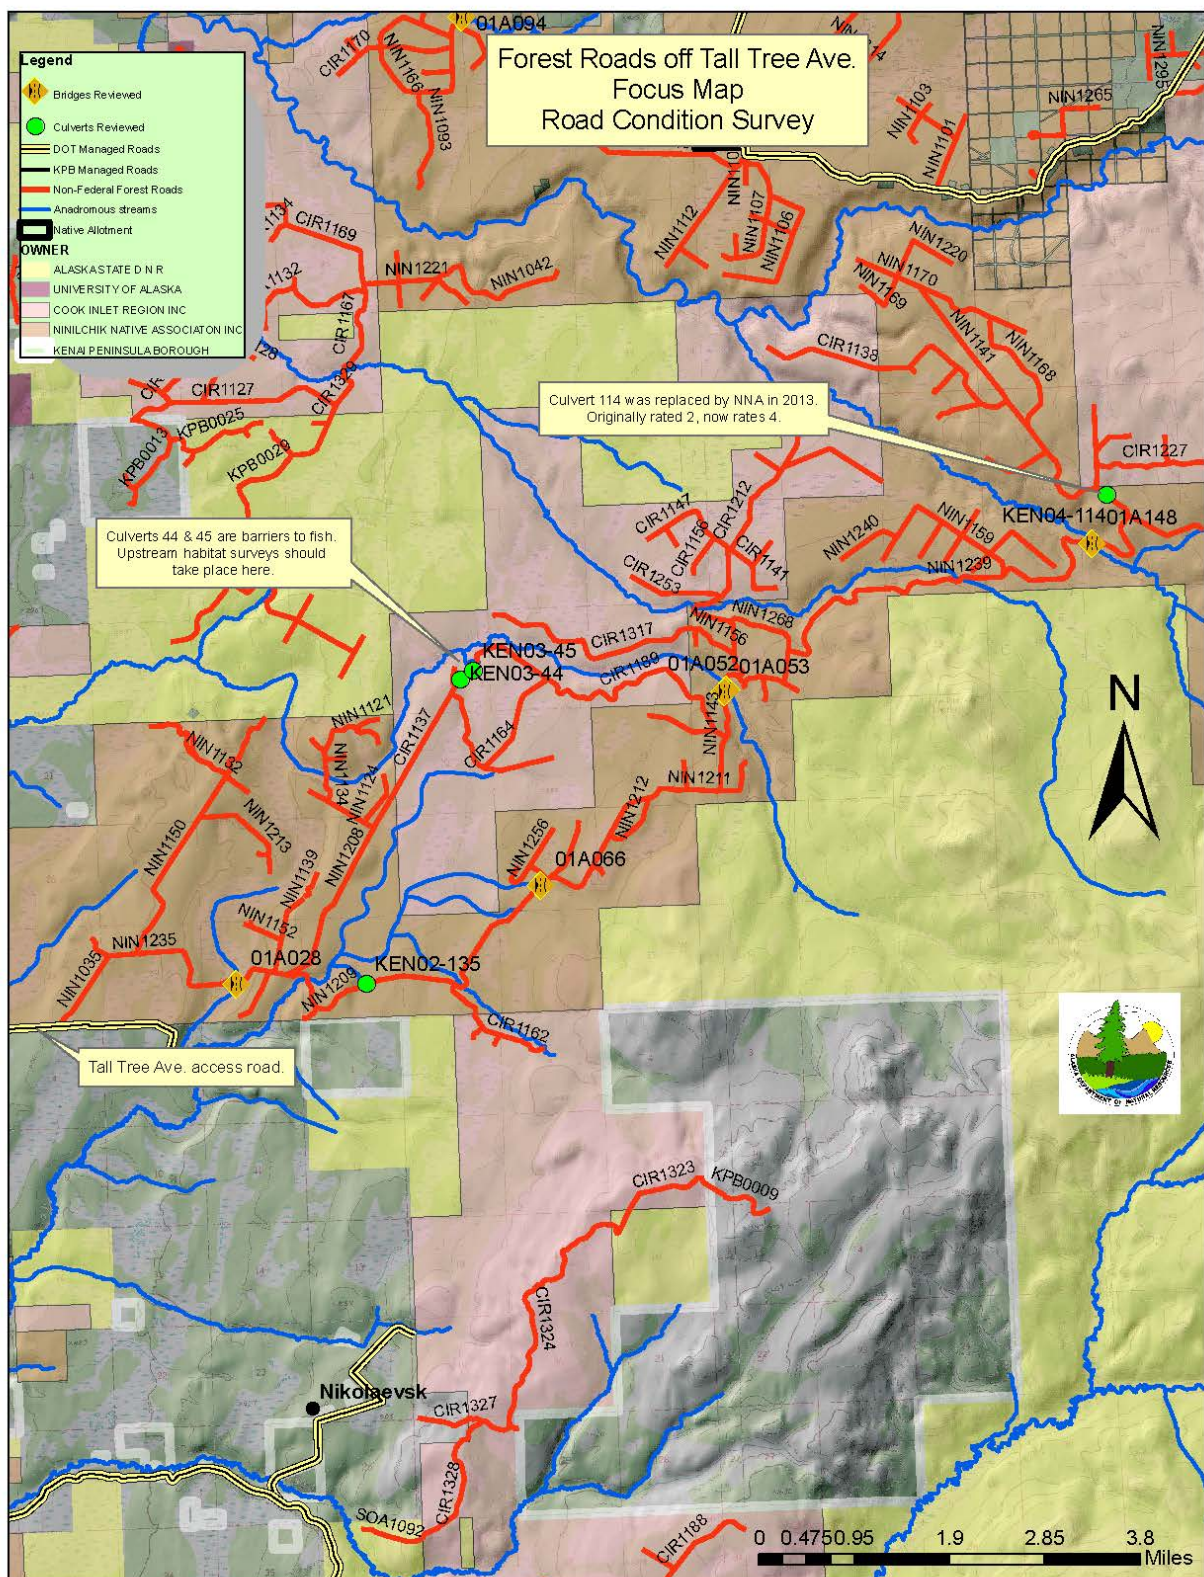
Figure 9. Map showing low-rated fish culverts and a replaced culverts by NNA.

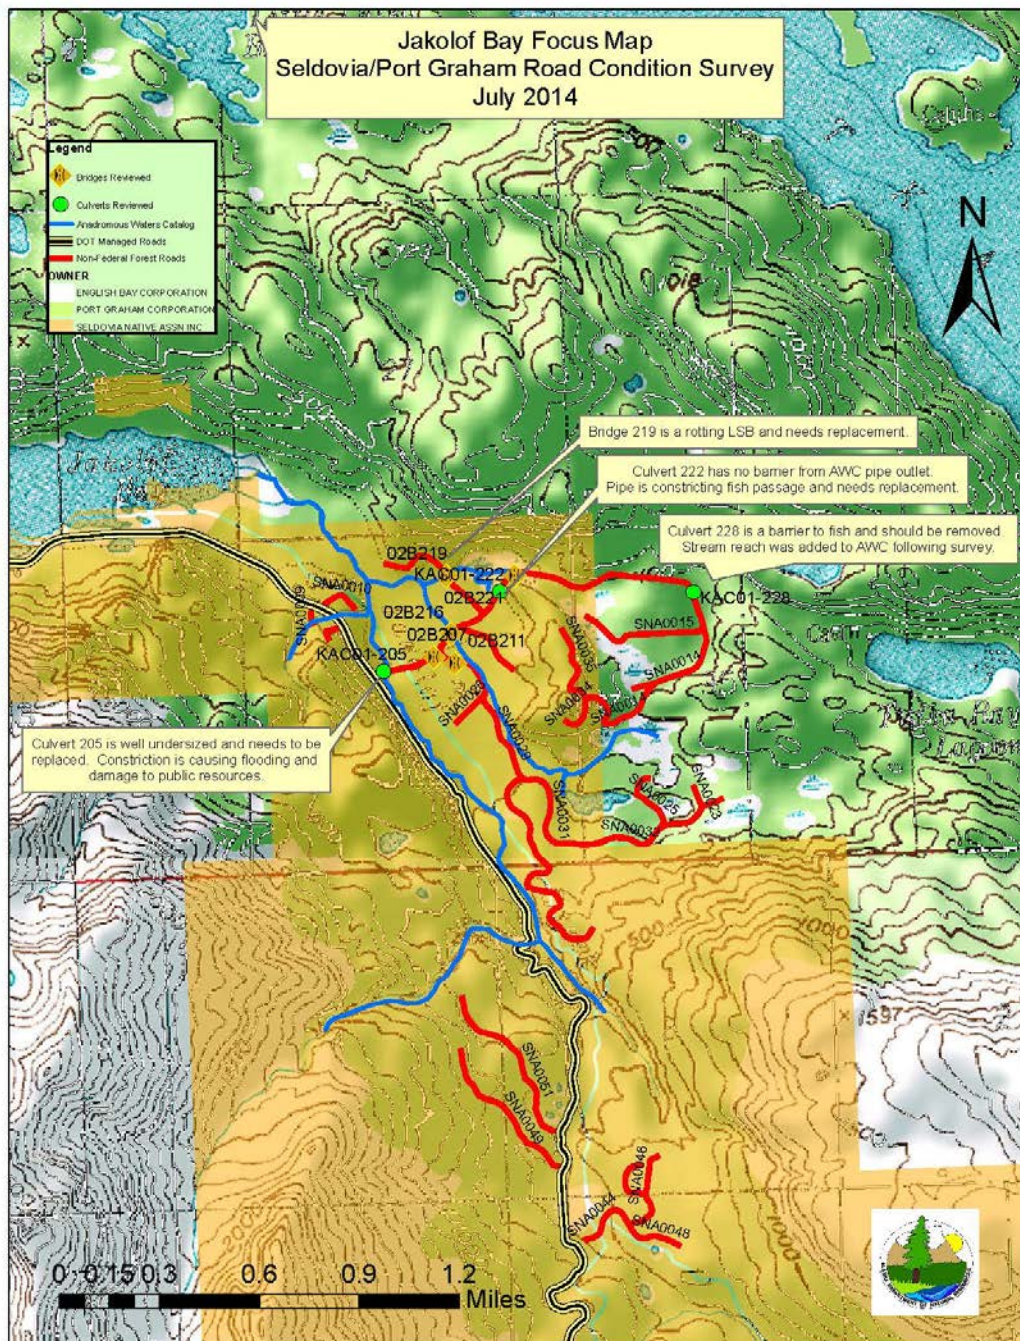
There are three low-rated culverts in close proximity of each other in the Seldovia area. They're all in the Jakolof watershed and need to be replaced. The most problematic culvert was a 7-foot diameter pipe located in Jakolof Creek (see culvert KAC01-205 on Table 3). George Oliveira, Alaska Department of Transportation, Seldovia, explained that stream bed-load has aggraded above the culvert causing flooding and damage of the adjacent State highway. All three culverts are out of compliance with FRPA and Title 16, but the one on Jakolof Creek is causing the most visible damage and affects other public resources besides fish. DOF will work with Habitat and the landowners to rectify the problem. The landowners are aware of the problem.

Figure 10. Map showing low-rated fish culverts and a bridge needing replacement.

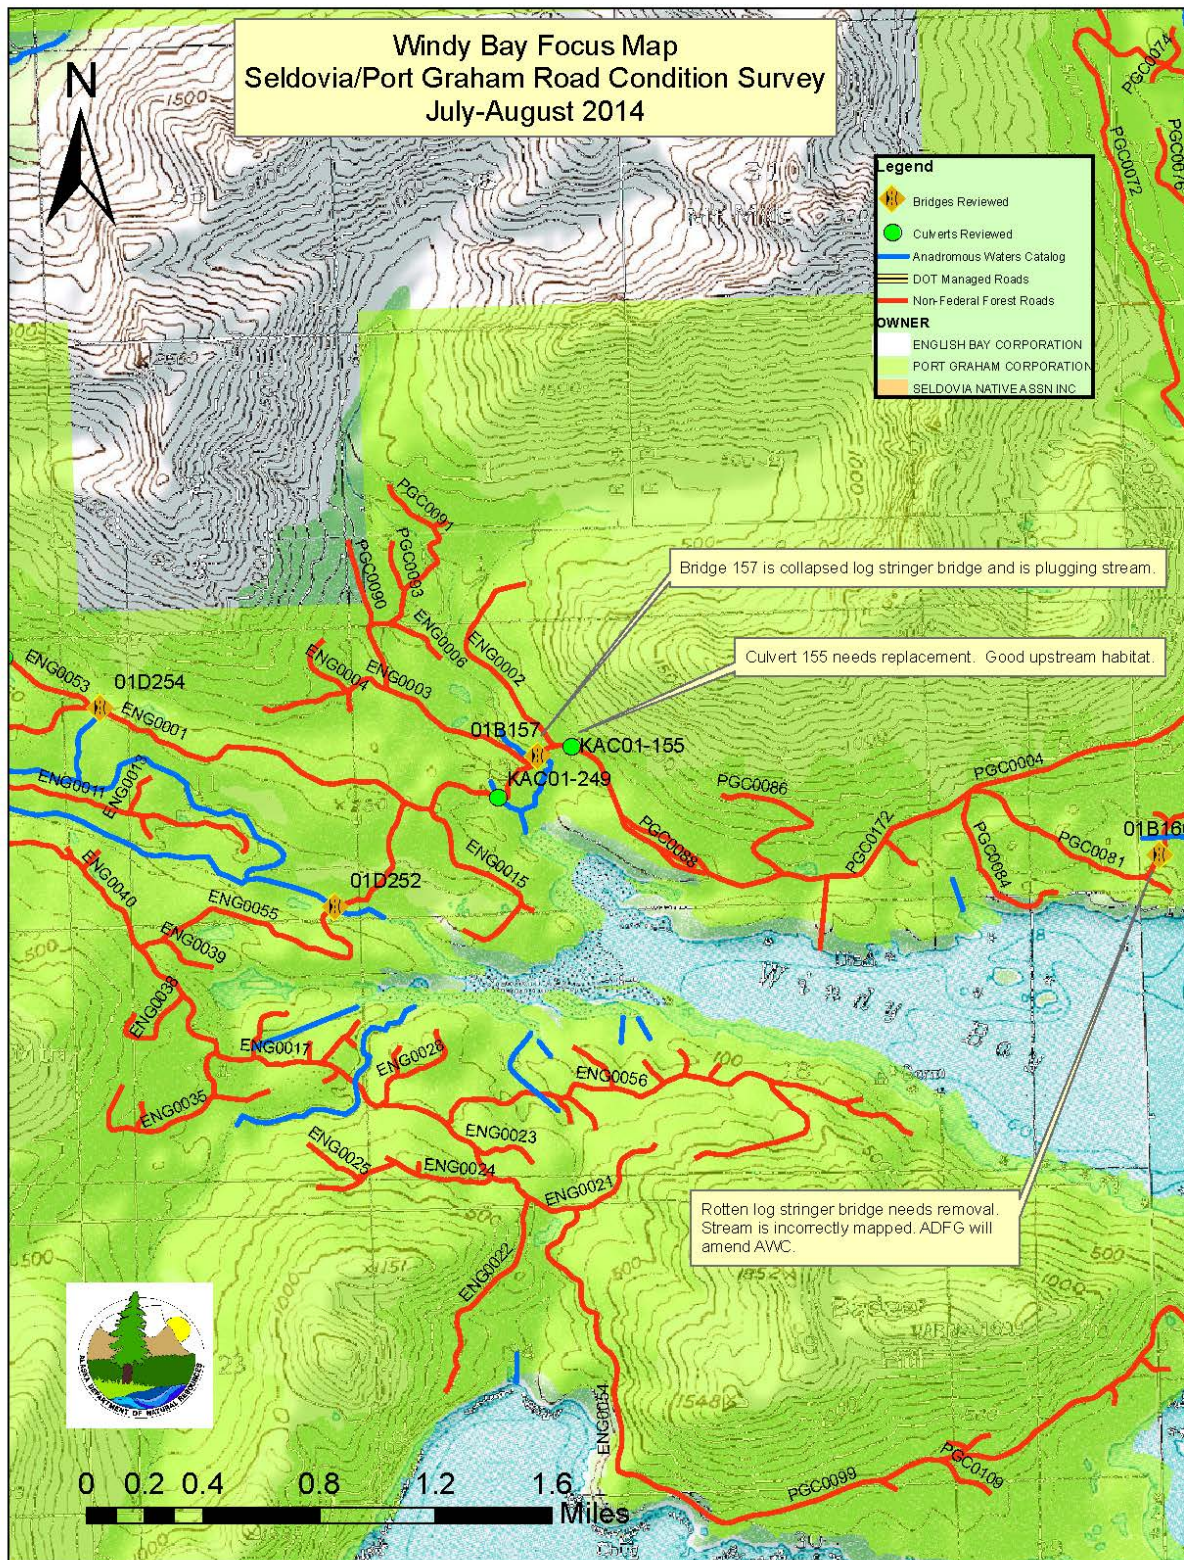
Figure 11. Map showing a low rated culvert and two bridges needing replacement or removal.

The six log stringer bridges highlighted in Tables 10 and 11 will need to be pulled apart, with the material moved away from where it could reenter the stream. One structure, 1B157 on a stream 242-32-10160 has fallen into the stream and a log jam has developed upstream of the bridge (see map on Figure 11, photo on Figure 17). About 75 adult pink salmon were observed spawning near the bridge, according to the Habitat biologist.

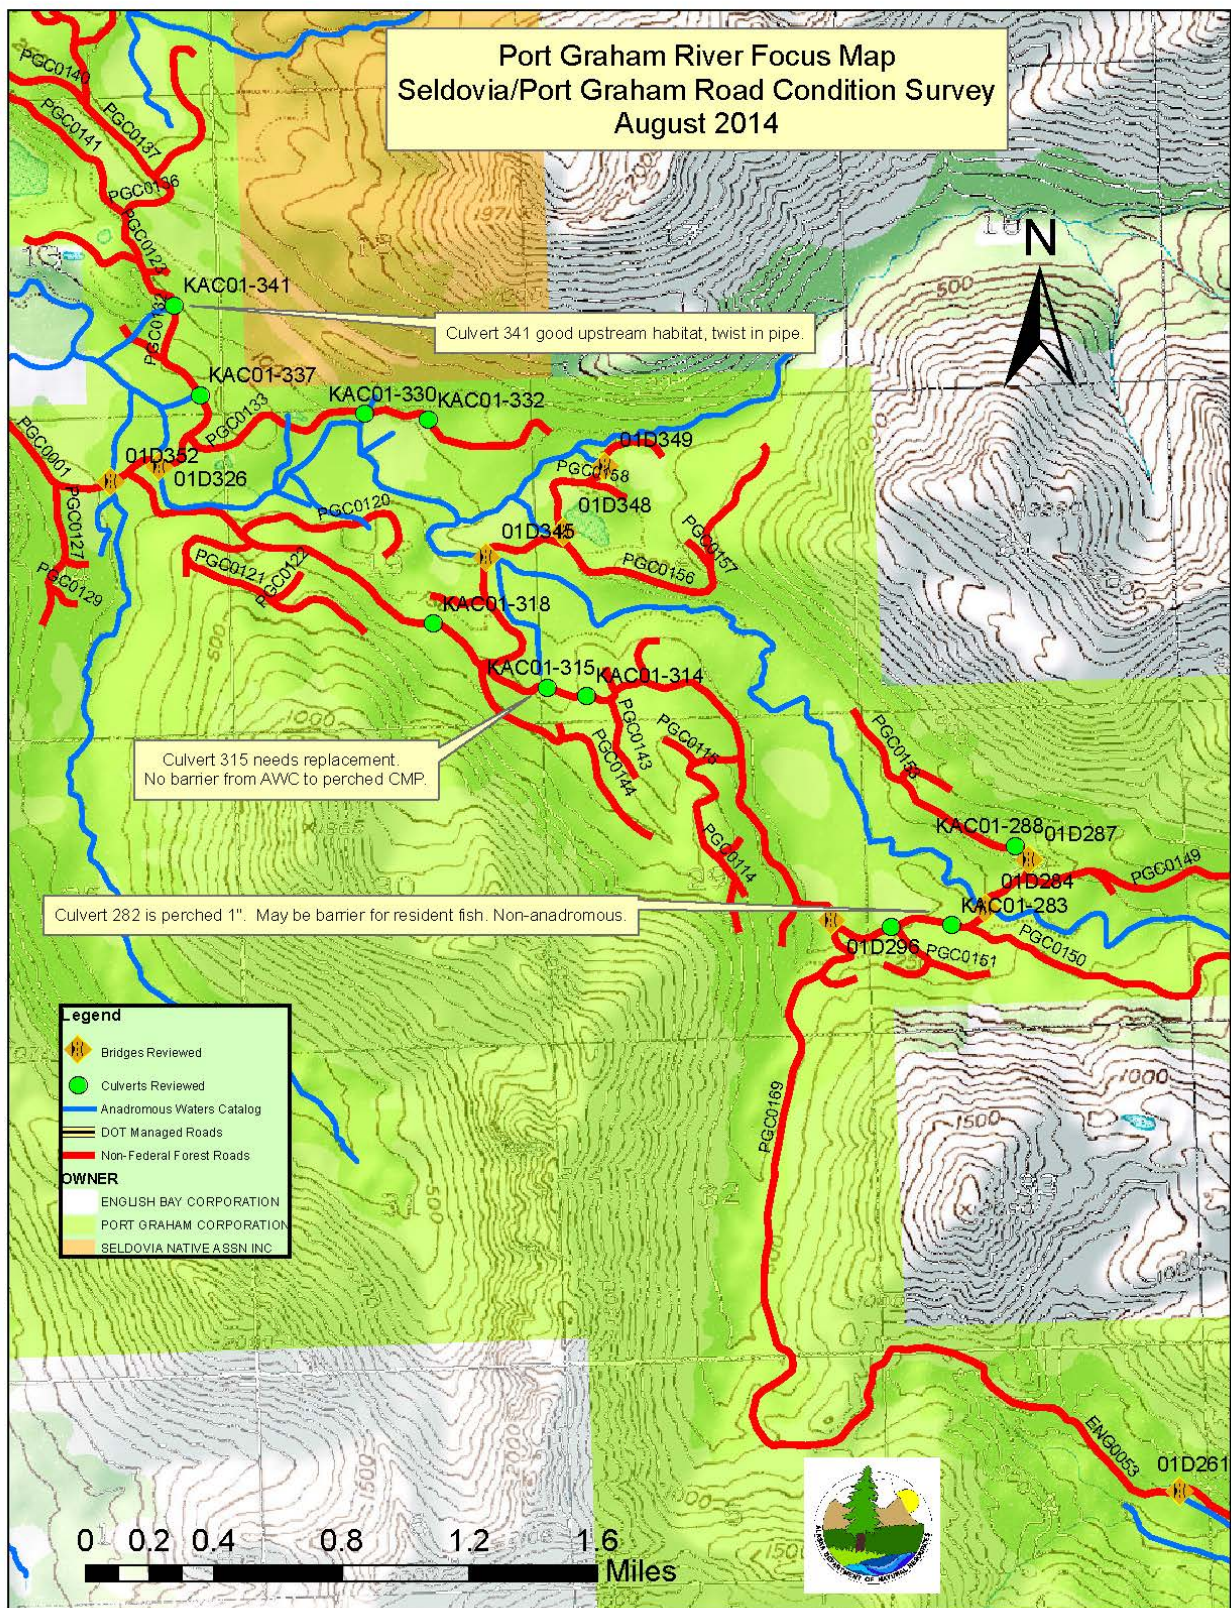
Figure 12. Map showing a low rated culverts in the Port Graham watershed.

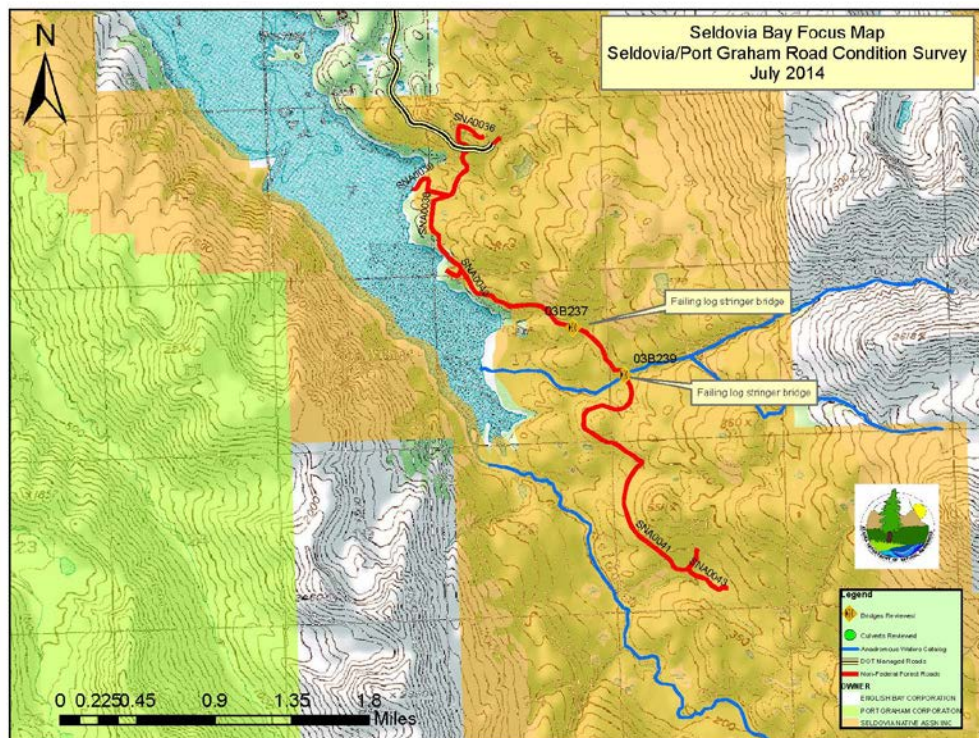
Figure 16. Map showing two failing log stringer bridges needing replacement or removal.
