Tongass National Forest

Water Quality Best Management Practices – Annual Monitoring Report

Fiscal Year 2019

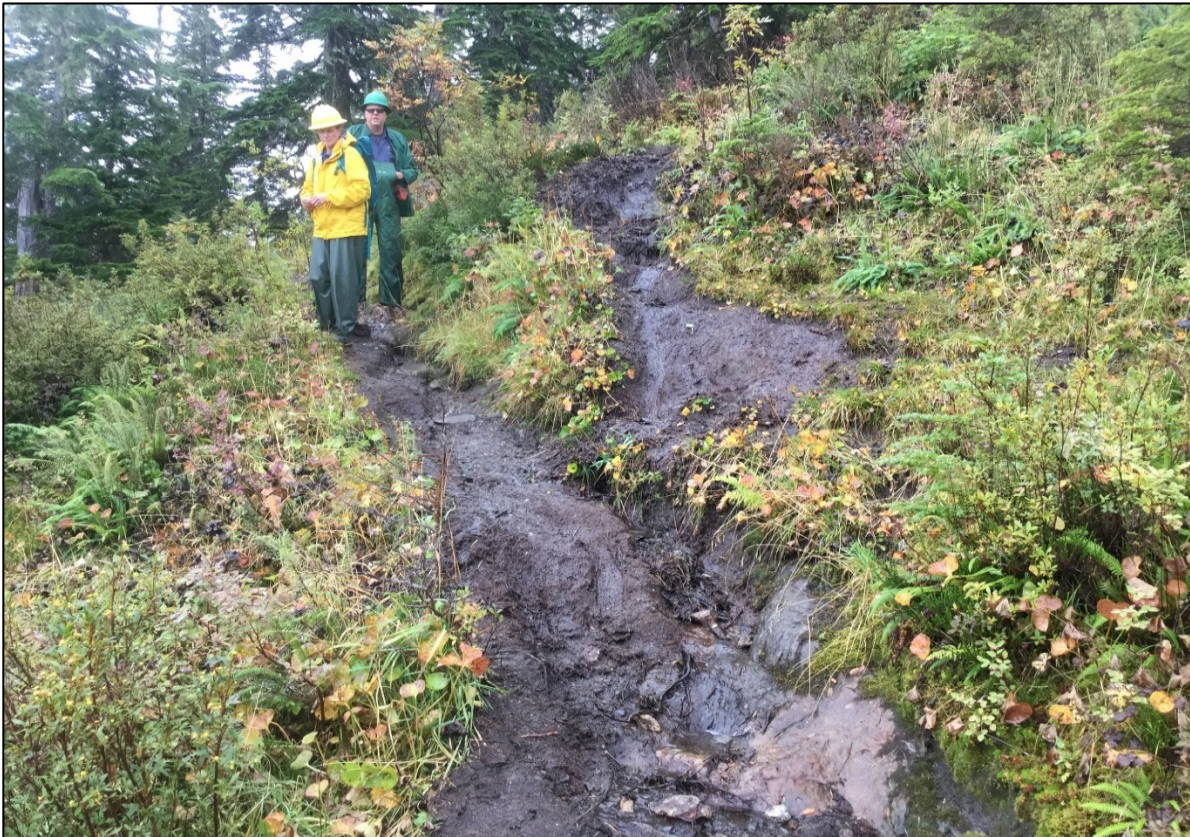
Photo 1. Dennis Landwehr, Forest Soil Scientist and Sue Howle, Ketchikan Misty Fjords District Ranger evaluating a segment of Dude Mountain Trail, KMRD.

Evidence of erosion and sedimentation was observed both inside and outside the evaluated waterbody crossing. Forms of erosion identified included rill and sheet erosion, rutting, vegetation damage and bare ground, and localized sediment deposition. Routine trail INFRA inspections have been completed on the recommended five year rotation. These inspections have documented maintenance needs that have gone unresolved, some of which have been contributing to the erosion and sedimentation issues observed in this evaluation. No evidence of trash or domestic animal or human sanitary waste was observed.

- Complete the 2019 Trail Assessment Condition Survey (TRACS) maintenance items that include BMP provisions to reduce trail erosion and sedimentation. The maintenance items include improved tread, water control features, geotextile mat replacement, rehabilitation of user created trails, and reconstructed or rerouted sections of trail.
- Install more frequent and longer water bars that fully span across the trail, using 3" base material for improved drainage in deeply incised sections of trail, deterring use of user created trails/shortcuts with brush and trail signs, and rerouting sections of trail along drier routes and extending switchback distances.
