Forest Practices Compliance Monitoring

February 2017

DIVISION OF FORESTRY

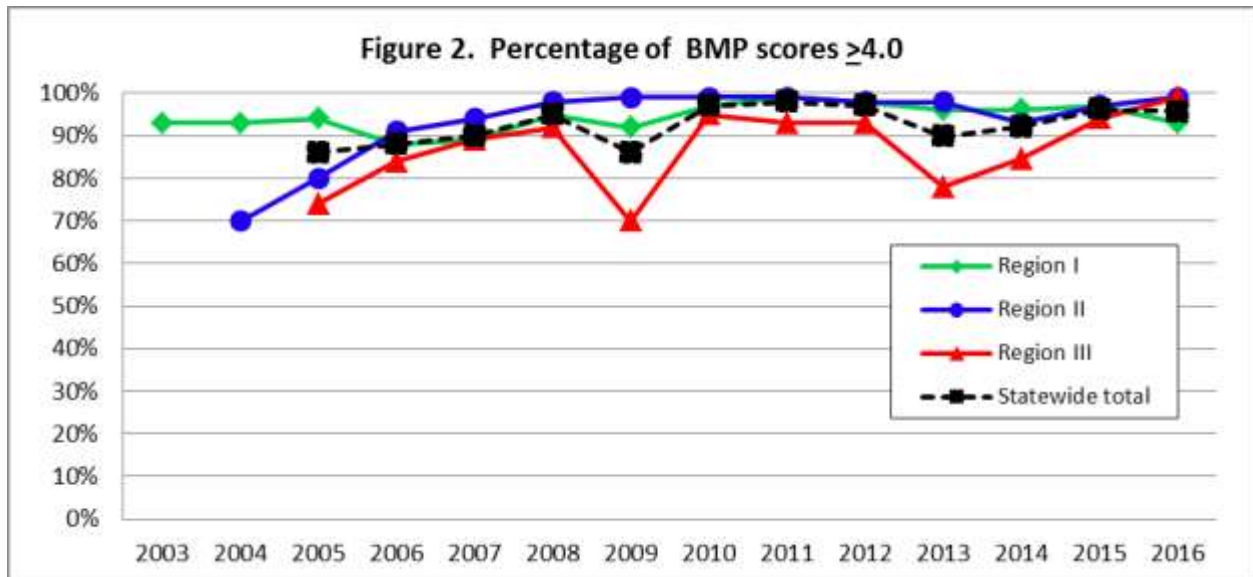
Results. Since 2003, the Division has compiled nearly 20,000 individual field ratings of best management practices. In 2016, the agencies conducted 80 field inspections on forest operations statewide and compliance monitoring score sheets were part of every inspection.¹ The data shows solid implementation rates in all regions. Overall, Regions I and II averaged 4.46 out of 5.0 on the ratings, and Region III scored 4.96. Figures 1 and 2 show the mean scores for each region and the percentage of BMP scores that are equal to or higher than 4.0.²

The ratings for Region III demonstrate the importance of the compliance monitoring program. Monitoring revealed road maintenance issues on state land in Interior Alaska, and the proportion of scores equal to or above 4.0 dropped to 70% in 2009 and 78% in 2013. The state responded with funding for road maintenance, and the Division of Forestry was able to strengthen maintenance activities and fix the problems. By 2016, Region III compliance monitoring scores achieved 99%.
